**MICROTENSILE BOND STRENGTH COMPARED BETWEEN CAD/CAM
FELDSPATHIC AND RESIN NANO CERAMICS**

A THESIS

Submitted in partial fulfillment of the requirements
For the degree of Master of Science in the
Department of Oral Biology
in the Graduate School of
The Uniformed Services University of the Health Sciences

FORT BRAGG, NORTH CAROLINA
2015

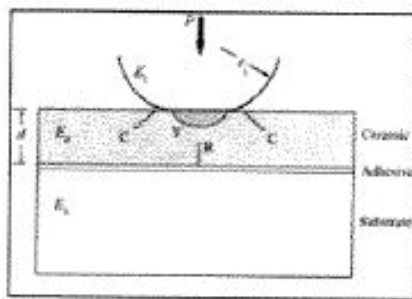
Figure 1. Schematic of brittle layer of thickness d and modulus E_C on a compliant substrate of modulus E_S , depicting sphere indenter of radius r_i . (Specimen radius r_c in general relation Eq. 1a is effectively infinite in the flat layer structure depicted here.) Damage modes: surface cone cracks (C); quasi-plastic yield zone (Y); inner-surface flexural radial cracks (R).

Figure from Lawn et al depicting cone and radial fractures

failure is fracture (12) (20) (21). Mormann et al, in 1991, published the results of the first 94 Vitablocs Mark I inlay restorations placed between 1985 and 1987. After following the cases for three years they reported only two fractures (22). Posselt and Kerschbaum, in 2003, placed 2,328 inlays and onlays in 794 patients and reported 35 failures from fractures over nine years (23). Otto and Denisco reported an 8 percent failure rate from fracture for 200 Vitablocs after a 10 year follow-up (7). The resistance to fracture of an all-ceramic crown is dependent on the core-veneered bond strength (when used), crown thickness, design of the restoration, and luting cements used to bond to the tooth (19). There are two types of notable ceramic fractures: the Hertzian cone crack (24), often resulting from surface damage on the occlusal surface that extends deeper into the restoration, and radial cracks that form at the cementation zone (25).

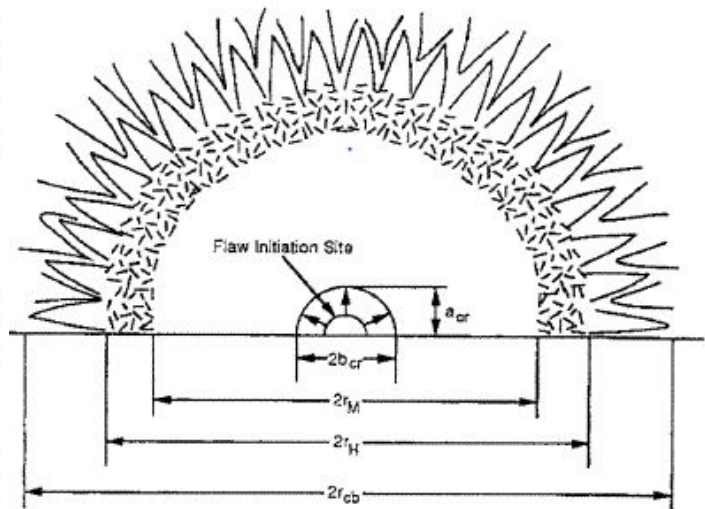
Figure 1. Schematic illustration of the fracture surface of a brittle material. Inner semi-ellipse represents the initial flaw, and outer semi-ellipse represents the critical flaw size. The subscripts M, H, and cb represent mist, hackle, and crack branching, respectively.

Figure from Thompson et al depicting fractography characteristics

Fractography is the study of the surface features and how they relate to crack propagation. Cracks go through a series of characteristics that change as the crack gains energy and velocity. Cracks begin as a smooth region termed the mirror, and then as energy increases secondary cracks may propagate giving a misty look, followed by the third region, hackle, where the secondary cracks are visualized branching in individual distinct paths (26). Quantitative fractography can be used to determine the source of the crack and calculate the stress at failure.

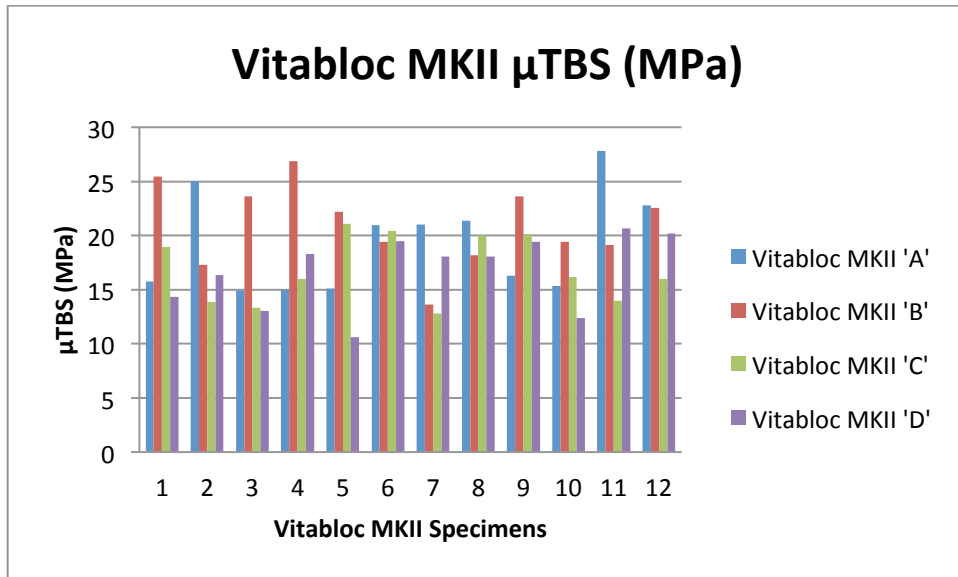
Graph 1. Results of the Vitabloc MKII μ TBS test

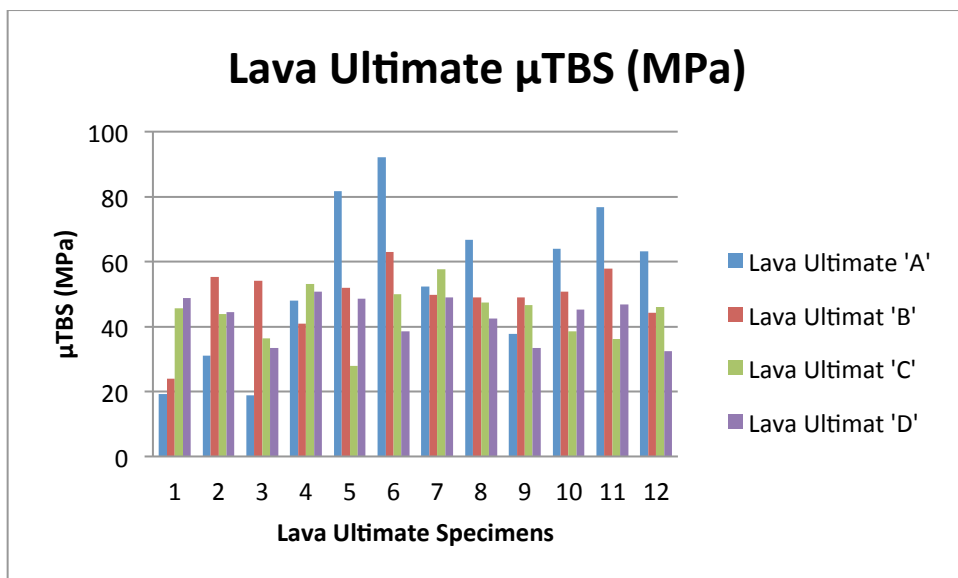
Graph 2. Results of the Lava Ultimate μ TBS test

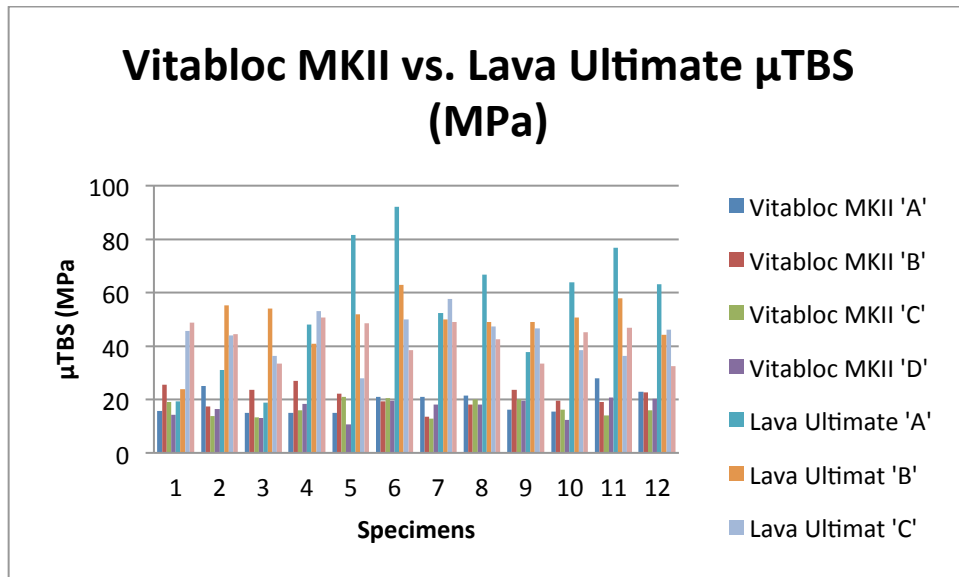
Graph 3. Compared results of the Vitabloc MKII and Lava Ultimate μ TBS

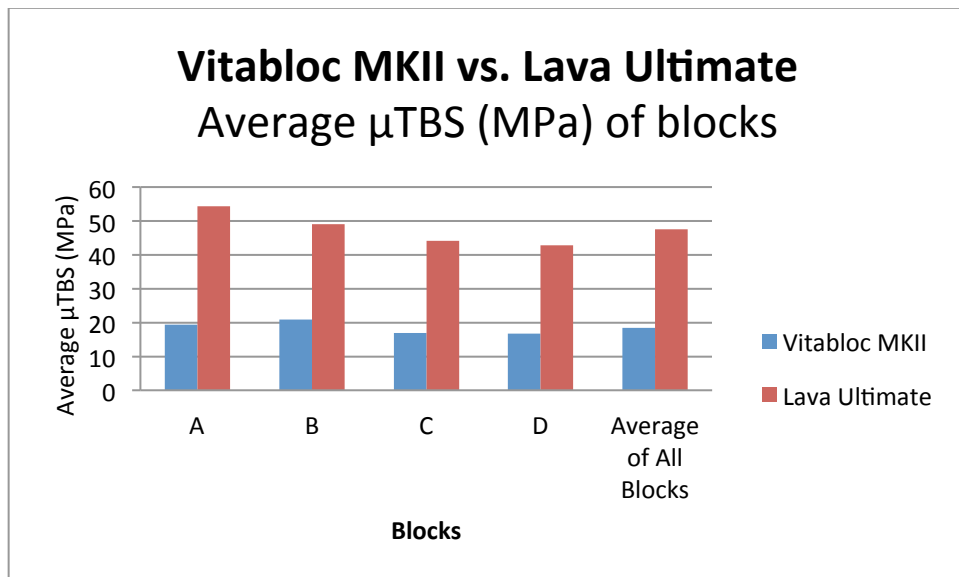
Graph 4. Compared means of the Vitabloc MKII and Lava Ultimate μ TBS.

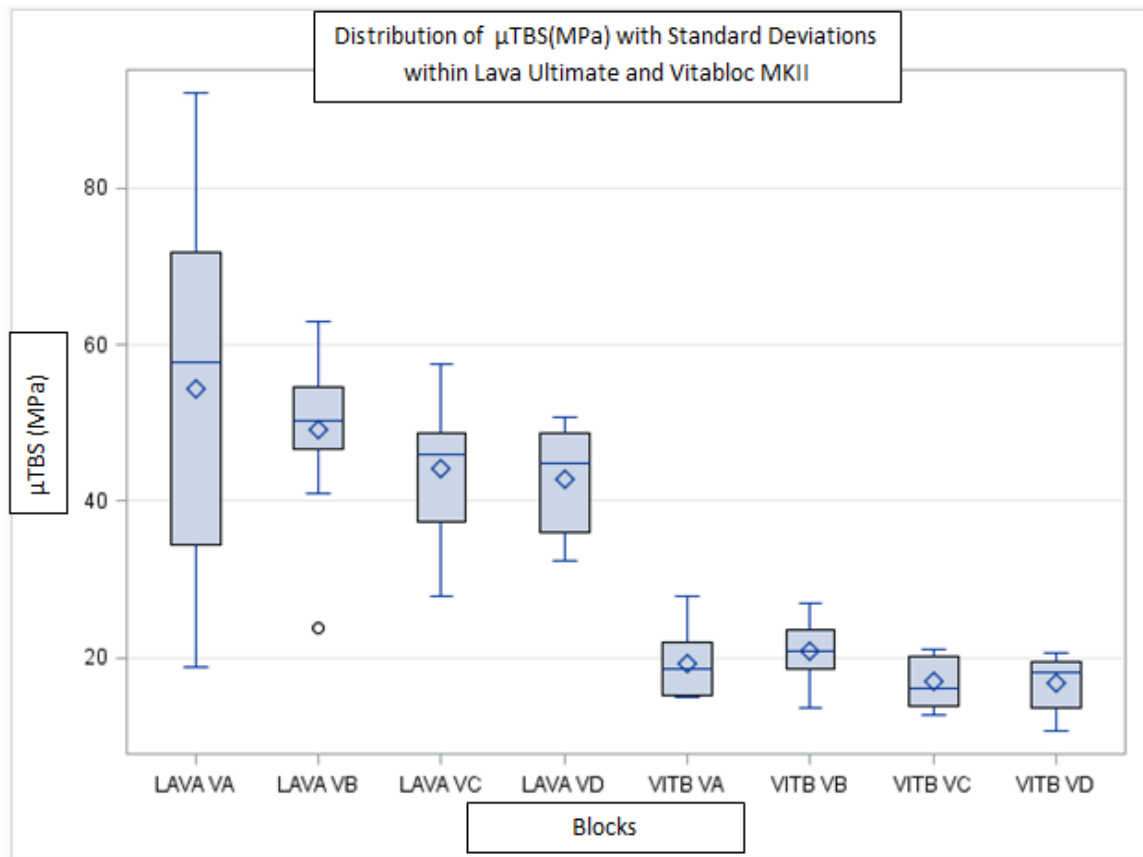
Graph 5. Distribution of mean μ TBS within the blocks 'A-D'. The mean value of the blocks were not statistically different within the Vitabloc MKII or Lava Ultimate (P value > 0.05).

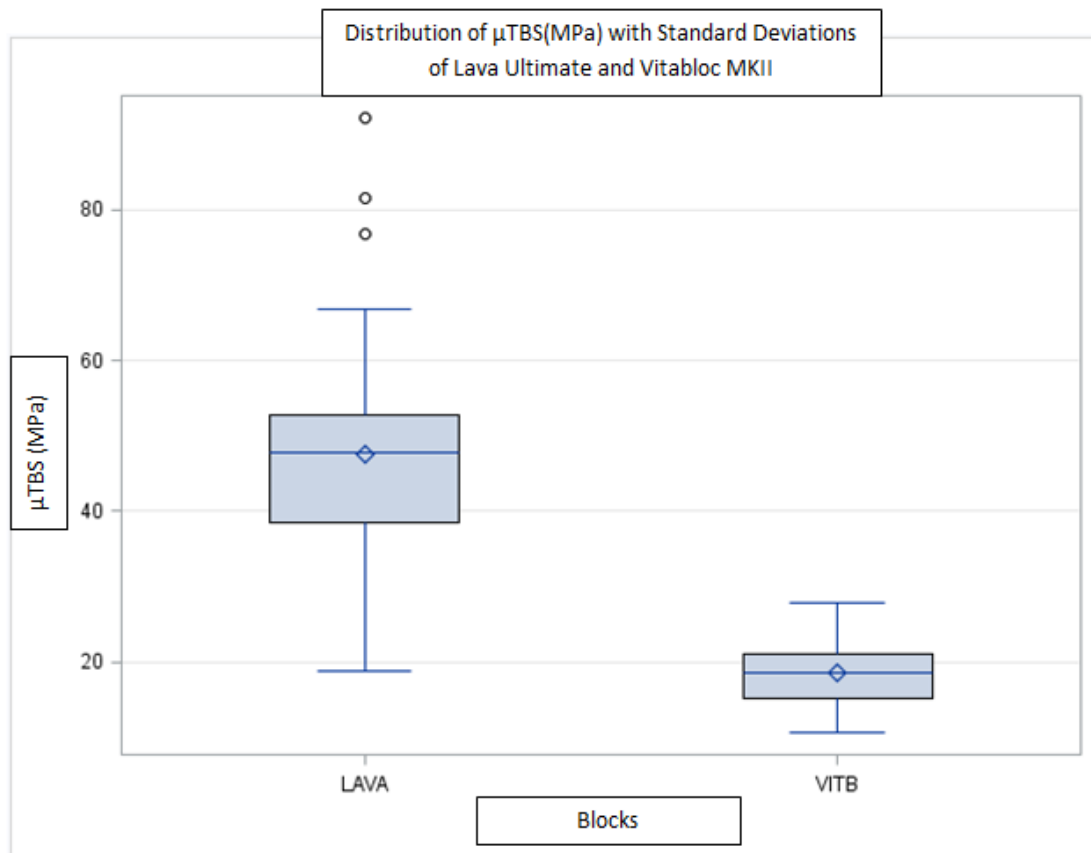
Graph 6. Distribution of mean μ TBS of the blocks 'A-D'. The mean values between the Vitabloc MKII and the Lava Ultimate had a questionable statistical difference (P value = 0.052)

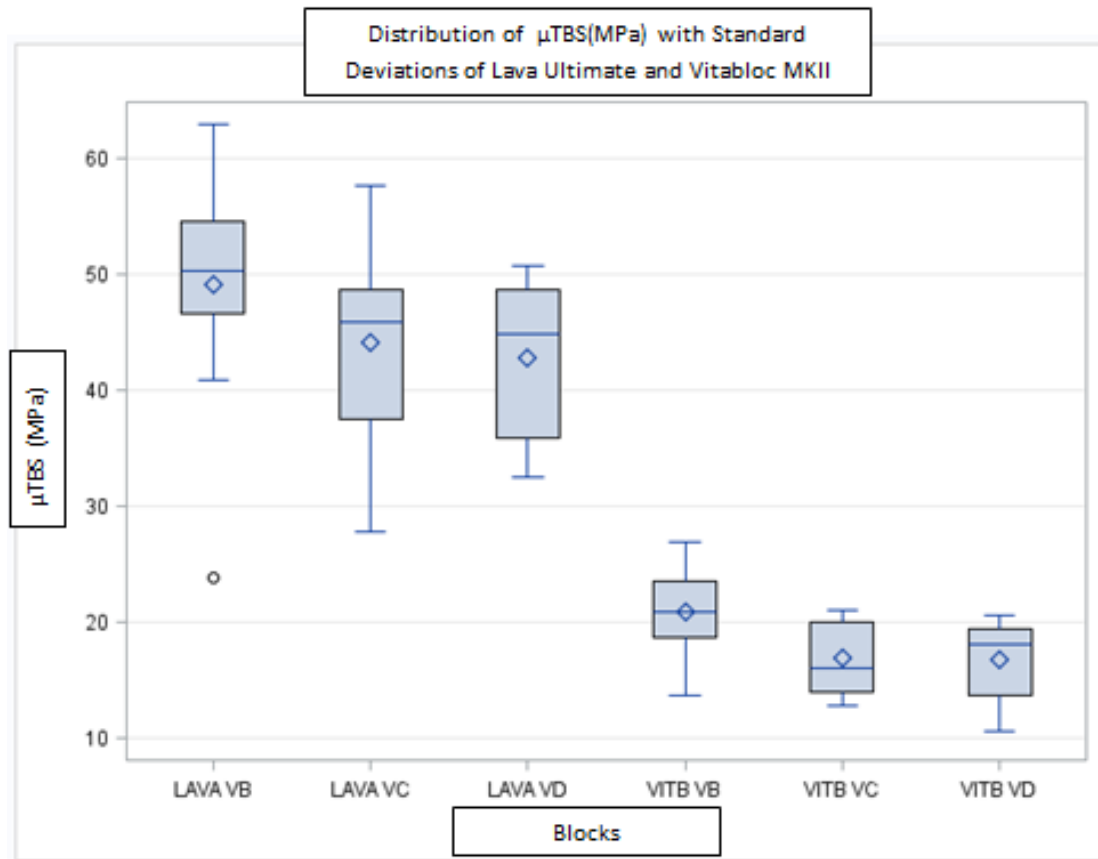
Graph 7. Distribution of mean μ TBS within the blocks 'B-D'. The mean value of the blocks were not statistically different within the Vitabloc MKII or Lava Ultimate (P value > 0.05, Confidence >95%).

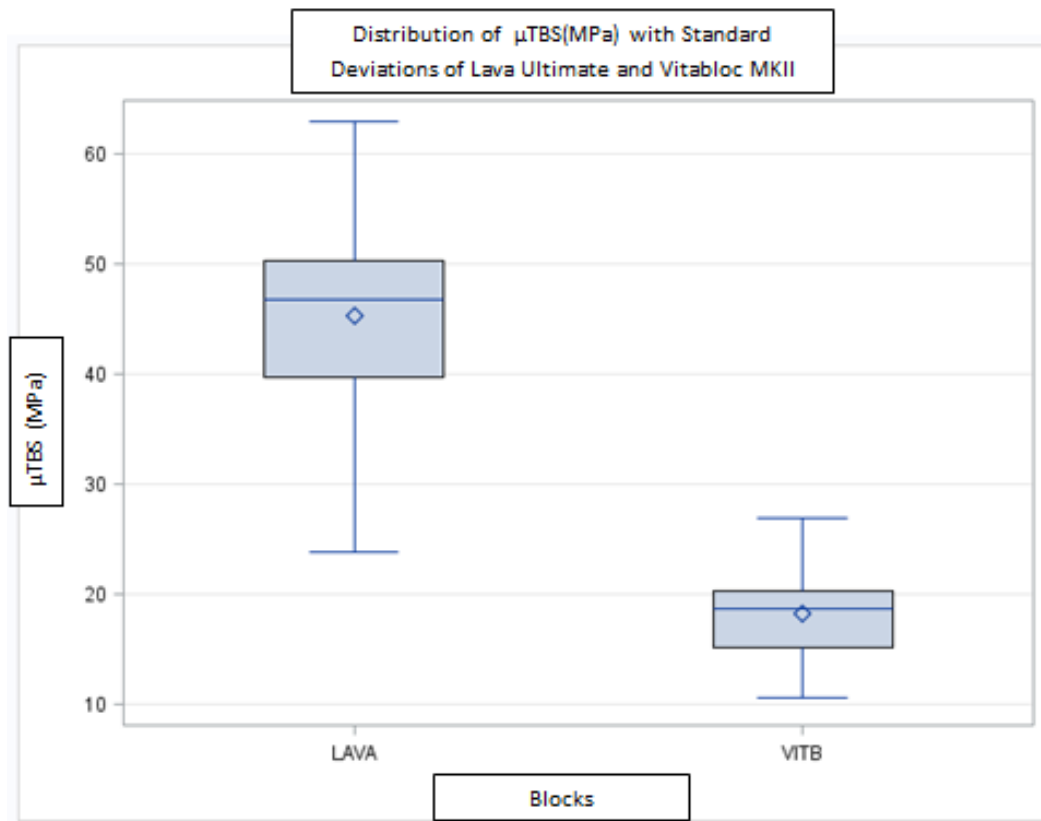
Graph 8. Distribution of mean μ TBS of the blocks 'B-D'. The mean values between the Vitabloc MKII and the Lava Ultimate were statistically different (P value = 0.011, Confidence > 95%)

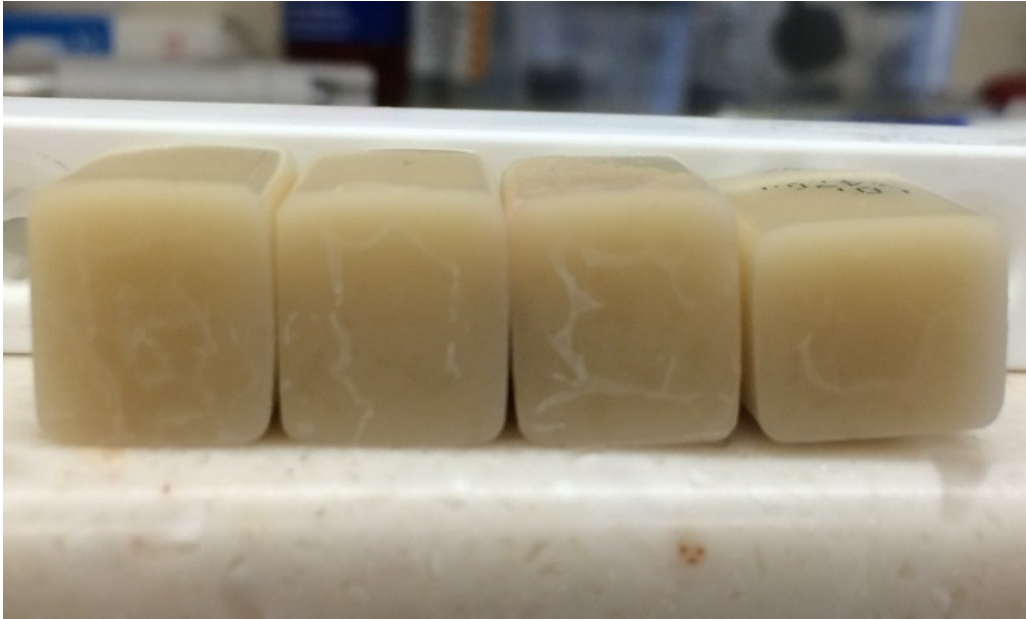
Figure 3. Vitabloc MKII blocks etched with hydrofluoric acid.

This was first major step where differences were seen. Reviewing the figures 3 and 4 of the surface treated blocks, the Vitablocs MKII appear to have similar pattern of etching. On the other hand, the Lava Ultimate blocks are a resin matrix and not glass, and therefore recommended to be sandblasted by manufacturer guidelines. Giving a uniformed surface treatment is difficult when the sandblasting device projects in a stream. Placing the sandblaster too close or for too long in one section will remove more of the block creating an irregular surface. Looking at the figure it is evident that the investigator over-blasted block 'A' and over-corrected by under-blasting block 'D'. Zohairy avoided this problem in their 2002 study by grinding the composite blocks on a polishing machine with 600 grit SiC paper (3).

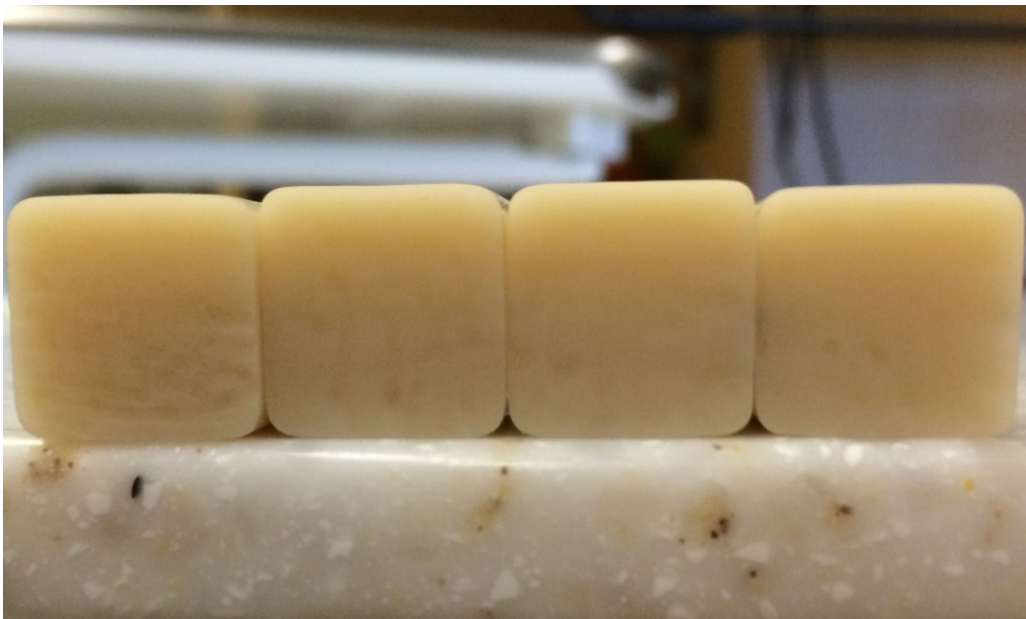
Figure 4. Lava Ultimate blocks air abraded.

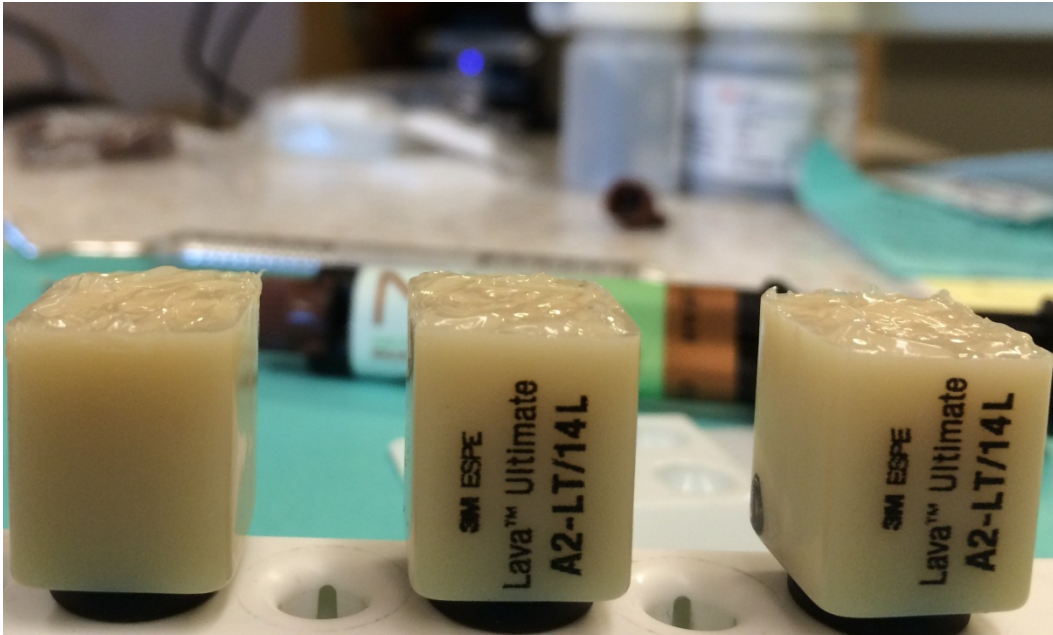
Figure 5. Lava Ultimate with a thin layer of cement.

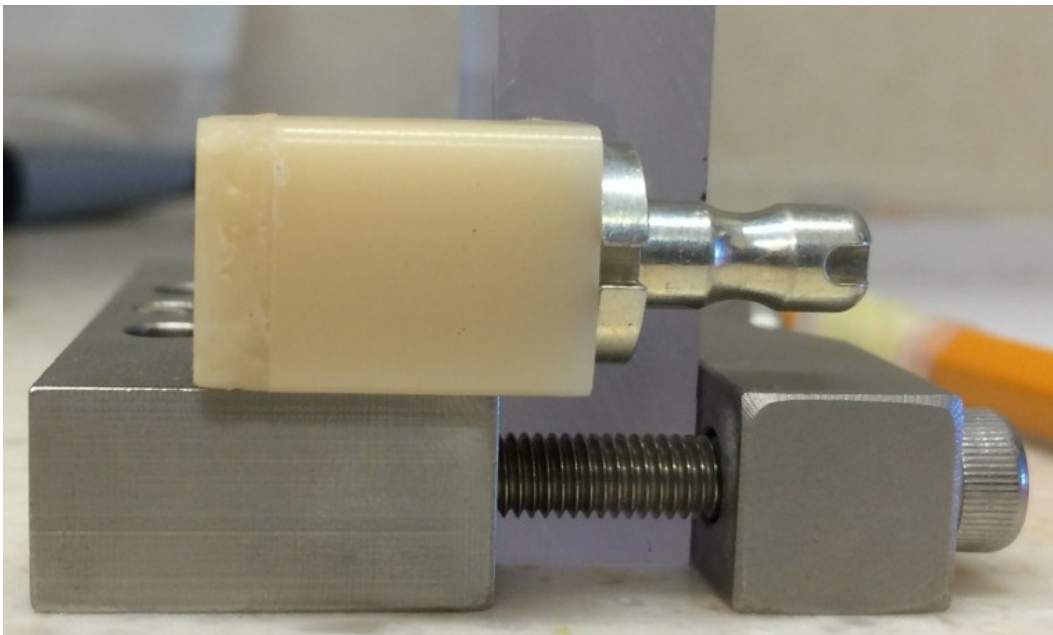
Figure 6. Block placed in sectioning jig.

Blocks were cut using a low speed cutting saw (Beuhler Ltd, Lake Bluff, IL). , Initial set of cuts making 1mm slabs were made perpendicular to the adhesive interface starting at the composite and moving towards the ceramic. The cuts were made >6 mm into the ceramic. The block was rotated 90 degrees and a second set of 1mm slab cuts made perpendicular to the adhesive interface starting at the composite and moving to the ceramic so that there are resulting 1 mm² slabs. The slabs were separated at the ceramic base with mild stress using thin dental instrument. Slabs were randomly observed under the 30x microscope for any obvious defects from cutting and measured with a digital calibrator to confirm the sizes were 1mm²(+/-0.5). Twelve slabs were randomly selected from each block. The slabs were stored in distilled water at 37°C for 24 hours.

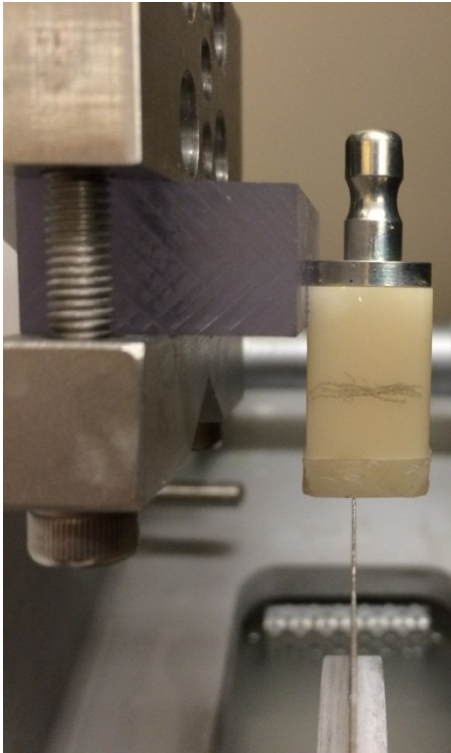
Figure 7. Block being sectioned with low-speed saw.

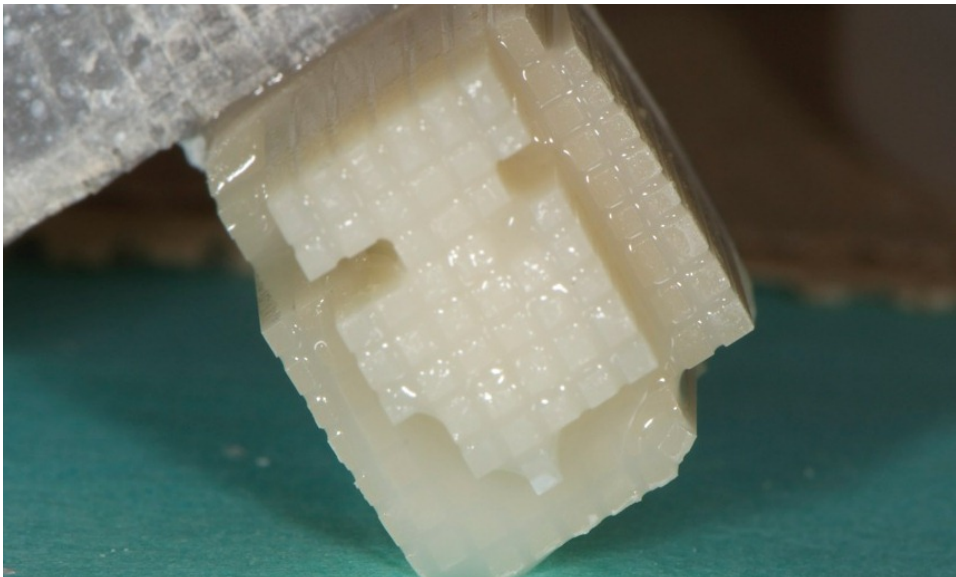
Figure 8. Slabs that have been lost or premature debonding during sectioning of the Vitabloc MKII. This was not evident with the Lava Ultimate blocks.

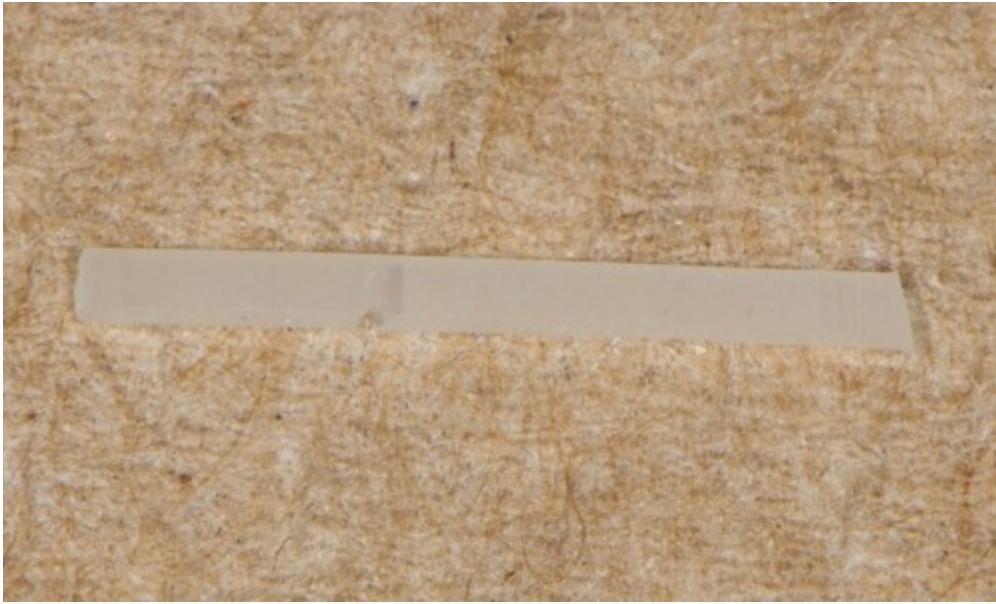
Figure 9. 1mm² Slab with defect from sectioning.

The slabs were viewed under a 30x microscope before and after applying tensile forces, but crack formation may not be detectable at the level and may need more enhanced viewing equipment such as SEM or stereomicroscope, which was not available. Della Bona recommends a thorough SEM examination of the materials and fractured surfaces. He also recommends confirmation of the restorative material's composition through x-ray elemental map analysis. Both of these ensure a more consistent and complete description of the fracture process and mode of failure (51). All slabs with known defects were not used for this experiment.

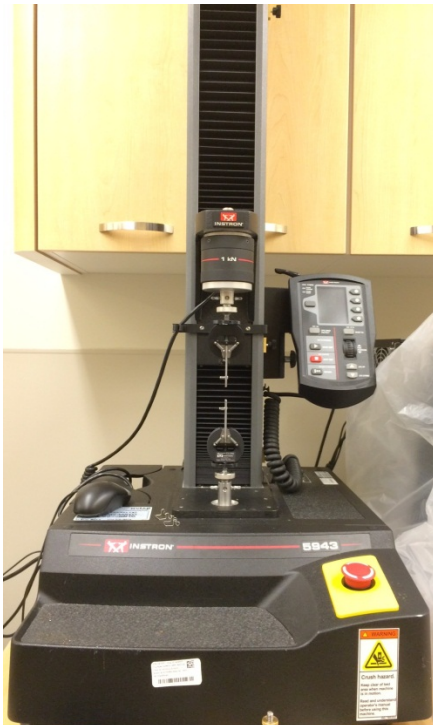
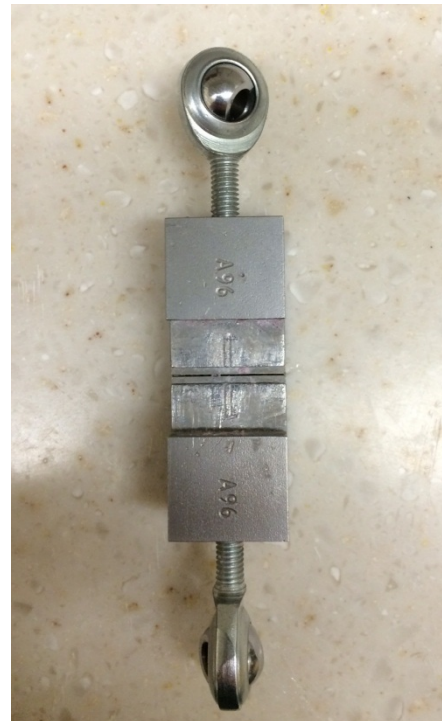
Figure 10 and 11. Instron 5843 Universal Testing Machine and μ TBS jig.

Slabs were bonded in a vertical direction on Instron universal testing plates with cyanoacrylate and placed in a universal testing machine (Model no. 5943 ; Instron; High Wycombe, Bucks, UK) under tensile stress with a crosshead speed of 1mm/min until failure. Micro-tensile bond strength calculations were made using the following equation: $s = L / A$, where “s” is the bond strength

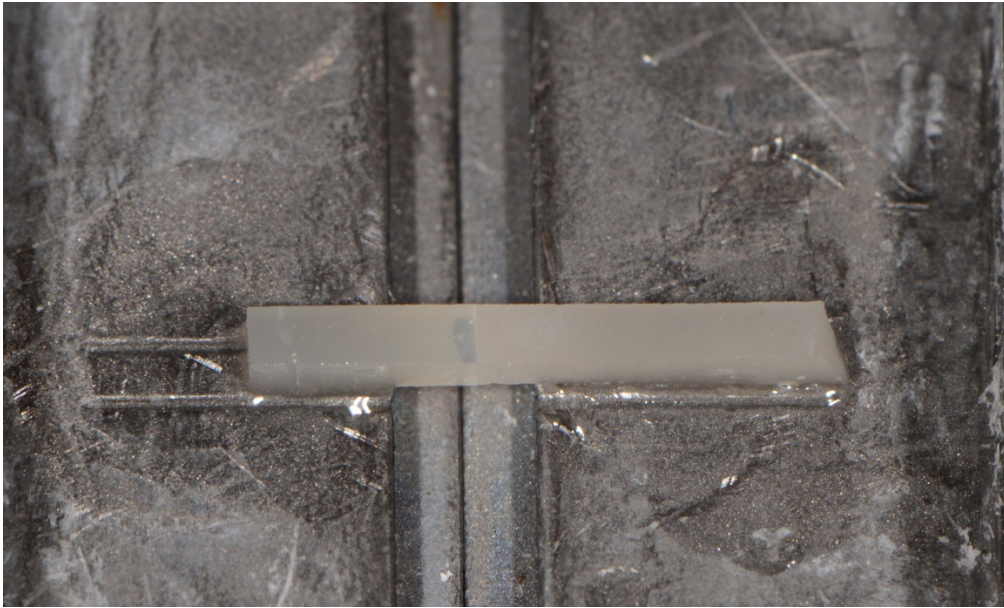
Figure 12. Lava Ultimate 1mm² slab with Z100 composite on left, cement layer in the middle, and Lava Ultimate on right.

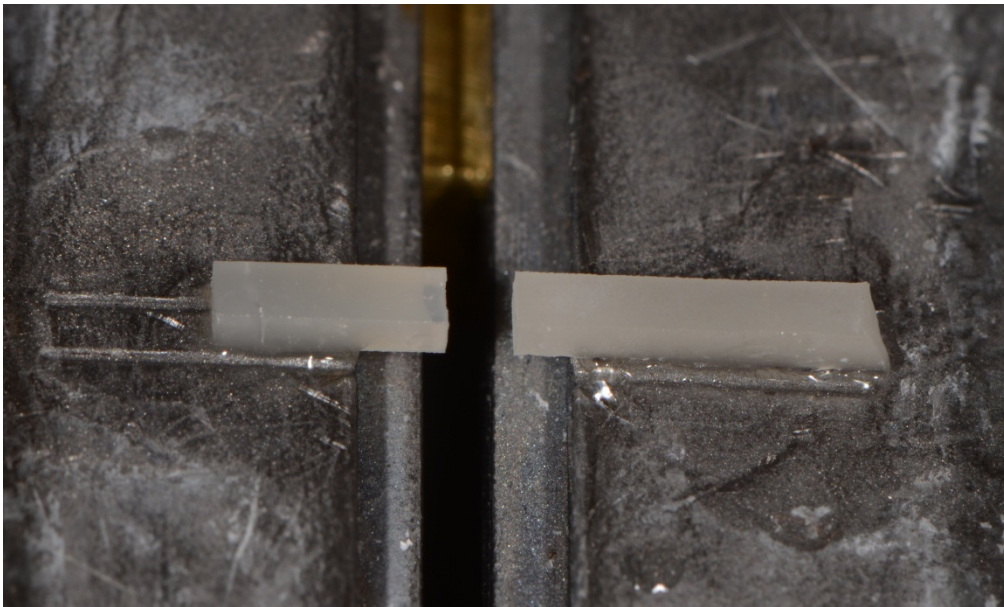
Figure 13. Lava Ultimate 1mm² slab demonstrating adhesive failure at the ceramic/cement interface.

Failure modes were categorized as one of the following types: A= Adhesive failure at the cement-ceramic interface; B= Cohesive failure in the ceramic; C= Cohesive failure mode in the cement; D= mixed A and B; and E= Mixed A and C. Since, the study is focused on micro-tensile bond strength of the ceramic material, only type A failure were acceptable for data collection. Two-Factor ANOVA test was performed to compare the failures within the block types and between the block types.

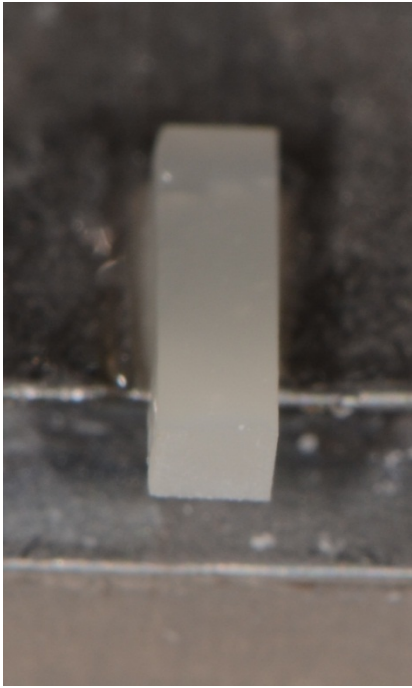
Figure 14. View of separated Lava Ultimate surface showing the adhesive failure.
